Minerals Inspection Report

Mine Name: Pine Ridge	Permit Number:	S/037/0120	Mine Status:	Reclaimed
Operator Name: Energy Fuels Resources (USA)	Inspection Date:	04/15/2014	Permit Fees:	No Fee Req.
Inspector(s): M. Bradley	Inspection Time:	08:00a	Bond Amount:	\$1,200
Attendee(s): See below	Weather:	Clr. Pt. Cldy, cool	Bond Escalation:	N/A
Inspection Purpose: Routine inspection			Prior Inspection:	08/27/2013

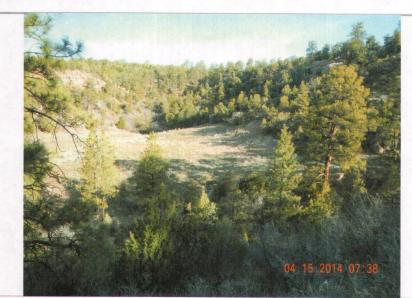
Overview of mine location

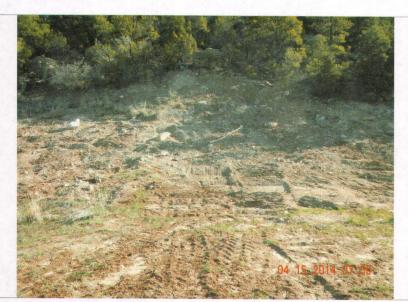
View toward approximate location of portal

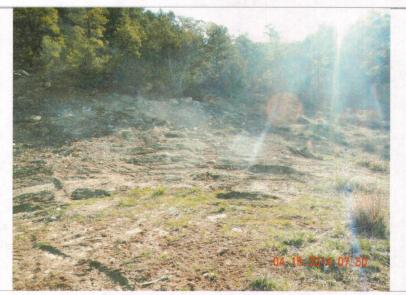
View toward east from near center of pad

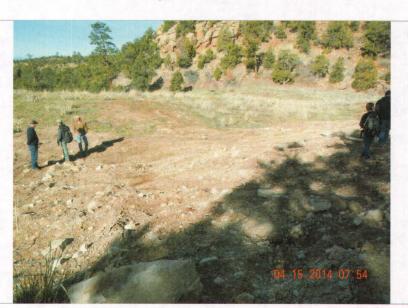
View from slope of backfilled portal toward west
